**THÈSE**

**Influence of casting defects on the  
fatigue behaviour of an A357-T6  
aerospace alloy**

**l'Institut National des Sciences Appliquées de Lyon**

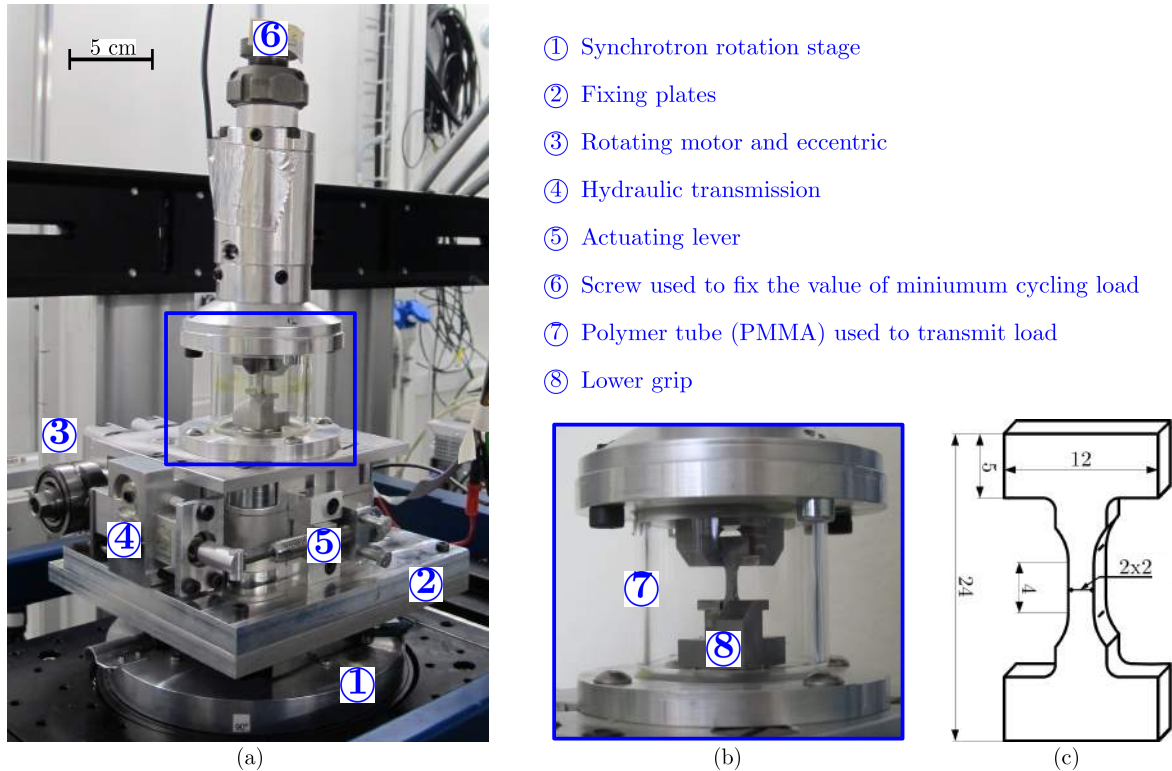
**Fig. 1.6:** *In situ* fatigue testing. (a) Fatigue machine setup at the SLS [LAC 12]. (b) Zoom of the PMMA tube. (c) Geometry of synchrotron specimens (dimensions in millimetres) containing natural defects.

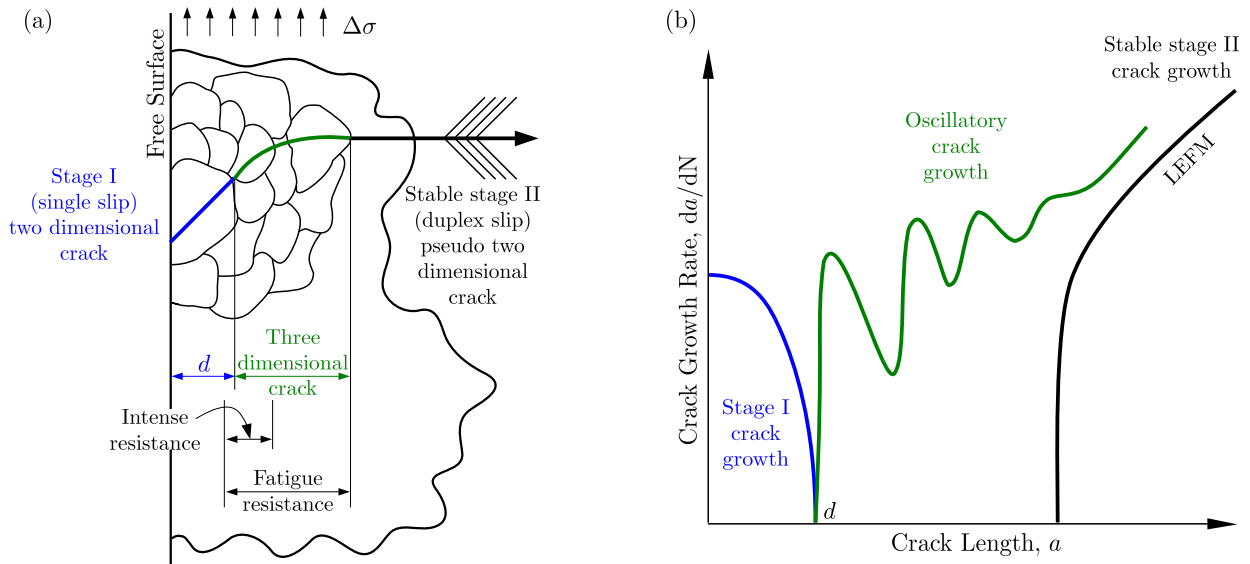
**Fig. 2.3:** (a) Schematic illustration of the fatigue resistance indicated in terms of difficulty for an initial stage I shear crack to become a stage II, tensile opening mode crack [MIL 93]. (b) Schematic illustration of oscillatory crack growth where  $d$  corresponds to the first microstructural barrier (able to arrest the crack) that opposing propagation [MIL 93].

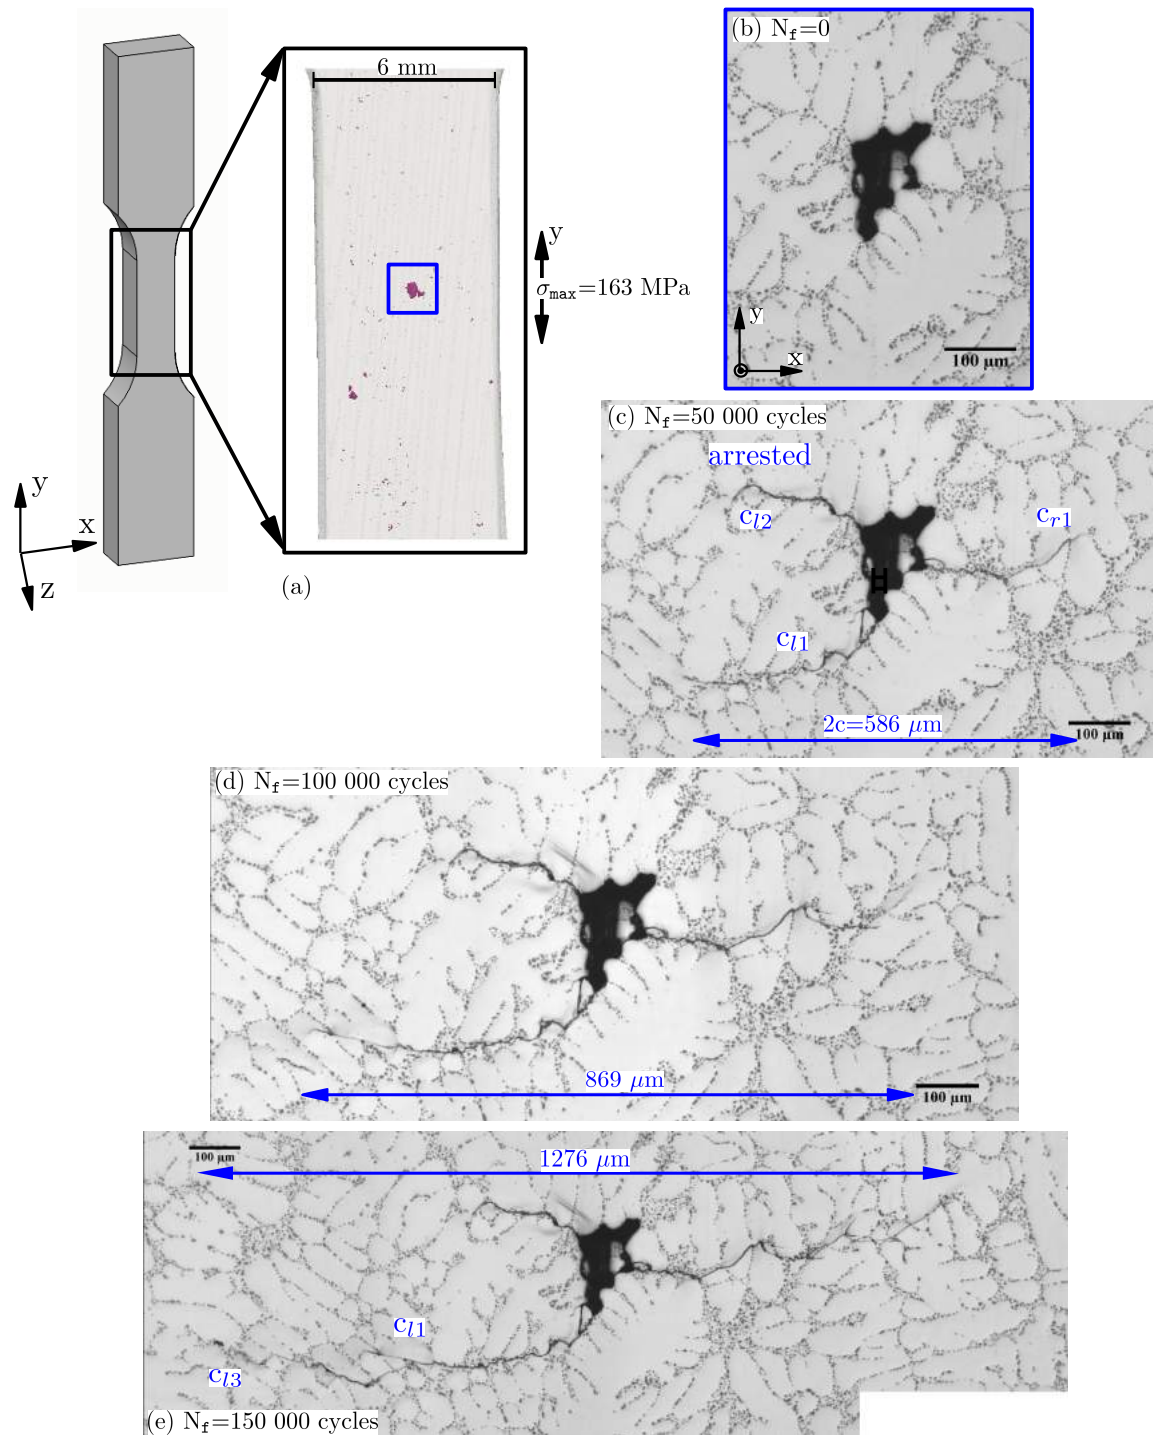
**Fig. 2.12:** (a) 3D rendering obtained using laboratory tomography (voxel size =  $12 \text{ μm}$ ) prior to uniaxial fatigue testing at  $\sigma_{\max} = 163 \text{ MPa}$ . The pore distribution is shown in magenta and the cracking pore is highlighted with a blue box. (b)-(e) Sequence of optical images presenting crack initiation at  $N_f = 0$  cycles and subsequent propagation stages until  $N_f = 150\,000$  cycles.

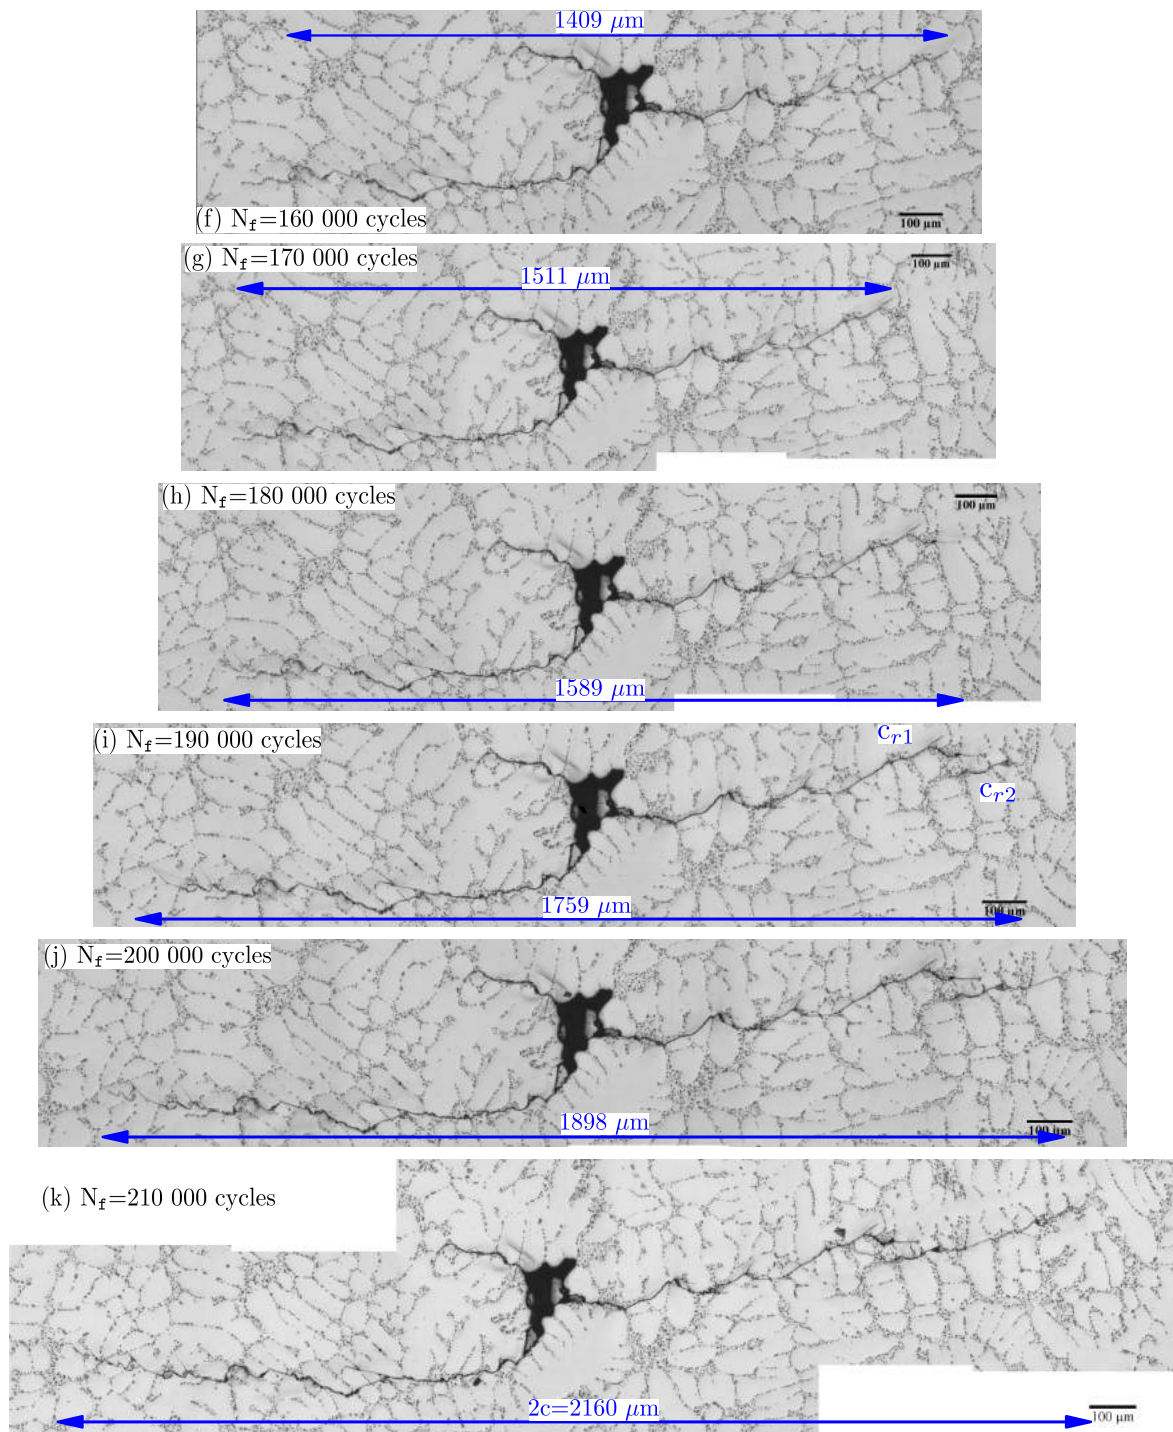
**Fig. 2.13:** (f)-(k) The same as the previous image but showing the crack progression from 160 000 up to 210 000 cycles where the experiment was stopped.

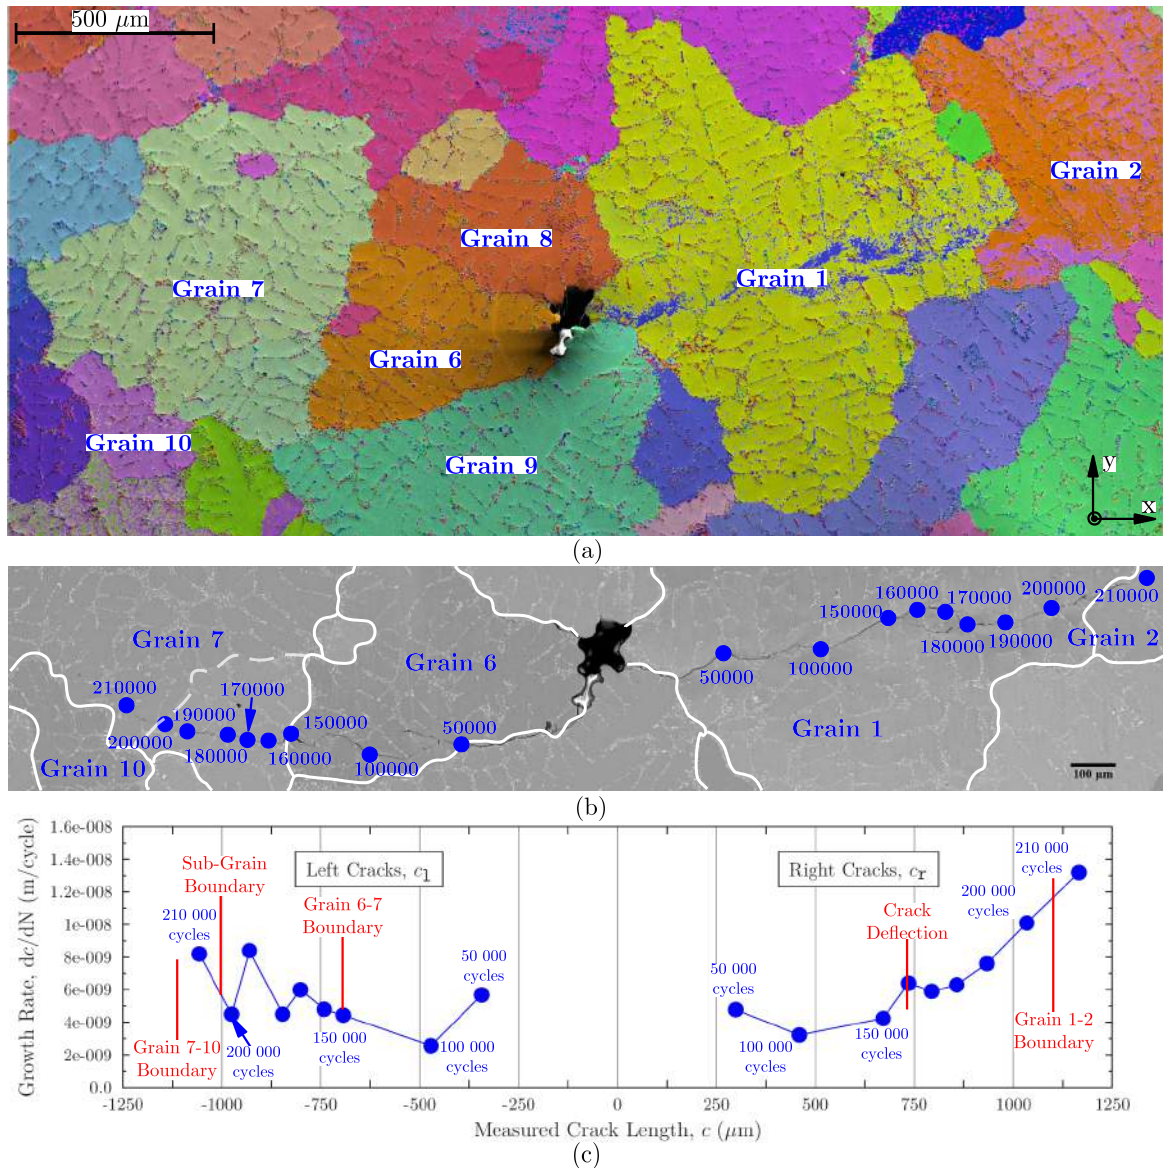
**Fig. 2.16:** (a) EBSD Euler map of the grain population around the pore and cracks. (b) BSE image of the crack path with blue circles indicating the observed stages of the propagation from 50 000 to 210 000 cycles. The white lines correspond to the approximate location of grain boundaries and the dashed line corresponds to a sub-grain boundary (lattice misorientation lower than 5°). (c) Plot of the crack growth rates ( $dc/dN$ ) against the measured crack lengths (c).

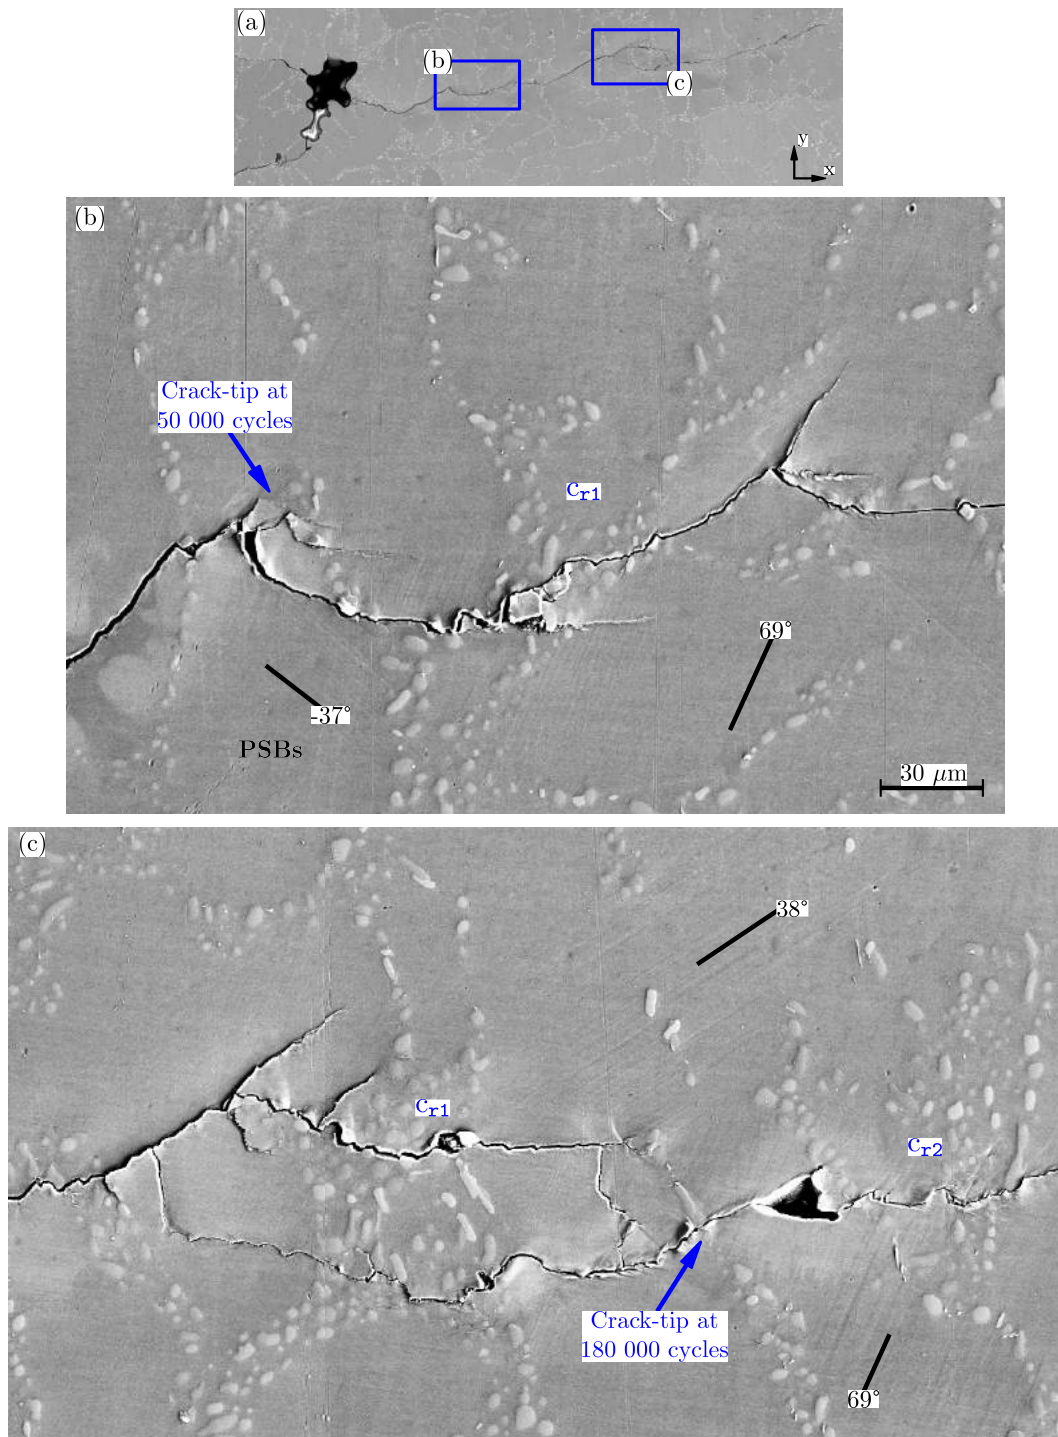
**Fig. 2.17:** (a) BSE image at low magnification of the right crack indicating the location of the details: (b) SEM image of the crack within Grain 1 where the PSBs observed on the free surface are indicated with black lines, and (c) the same as before but for a location closer to Grain 2.

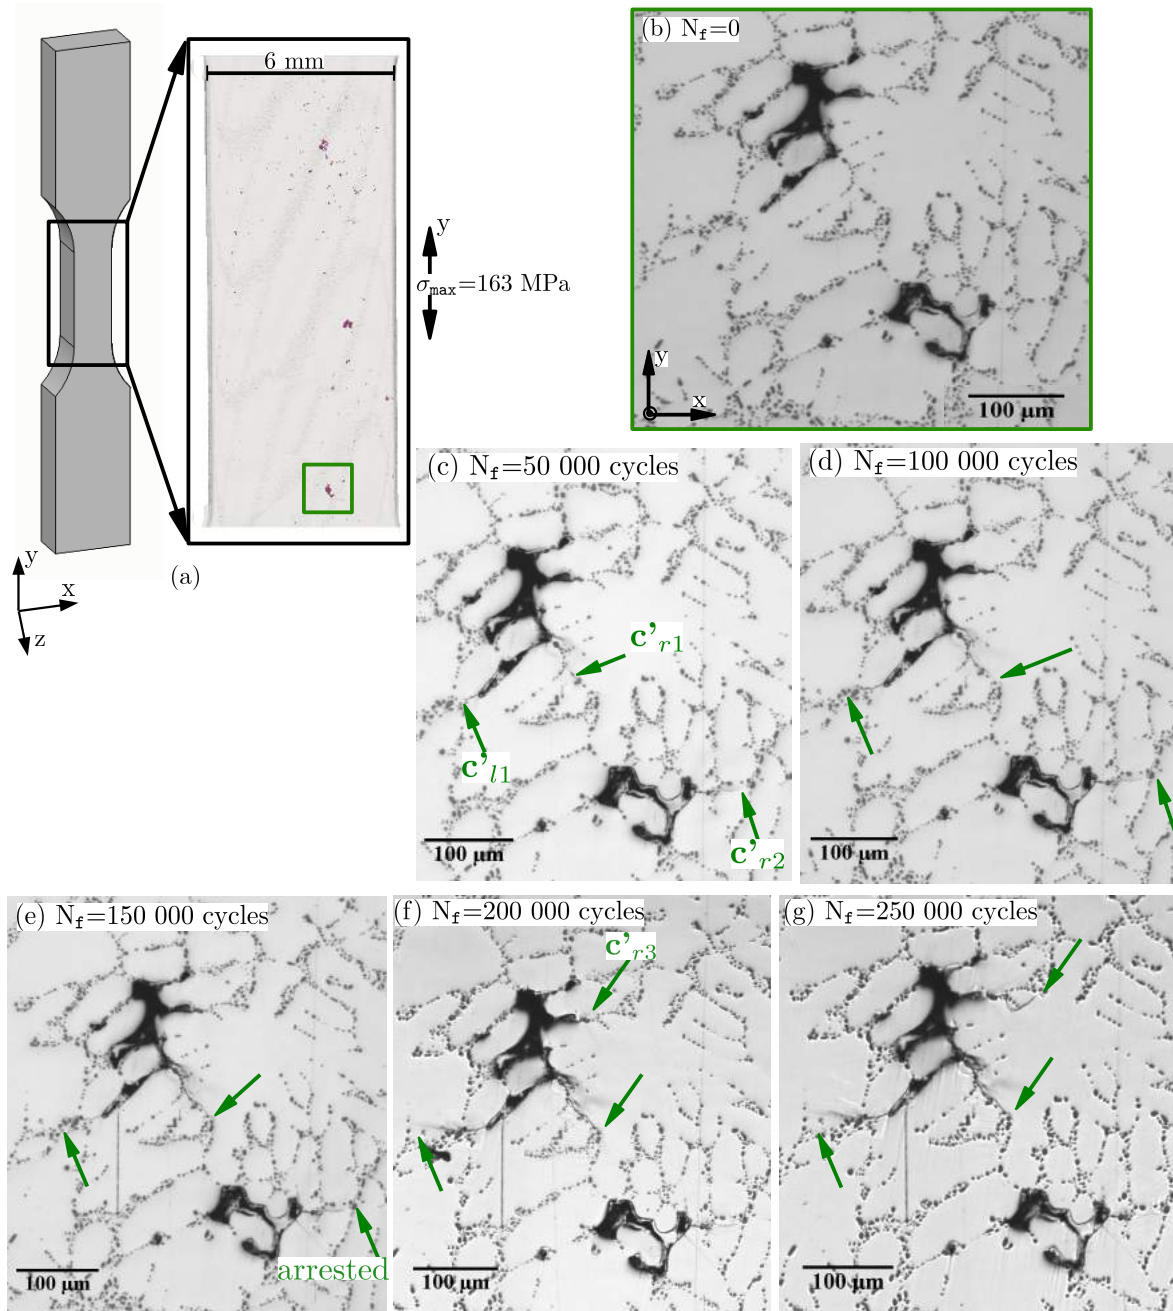
**Fig. 2.20:** (a) 3D rendering obtained using laboratory tomography (voxel size = 12  $\mu m$ ) prior to uniaxial fatigue testing at  $\sigma_{max} = 163$  MPa. The pore distribution is shown in magenta and the cracking pore is highlighted with a green box. (b)-(g) Sequence of optical images presenting crack initiation at  $N_f = 0$  cycles and subsequent propagation stages until  $N_f = 250\,000$  cycles.

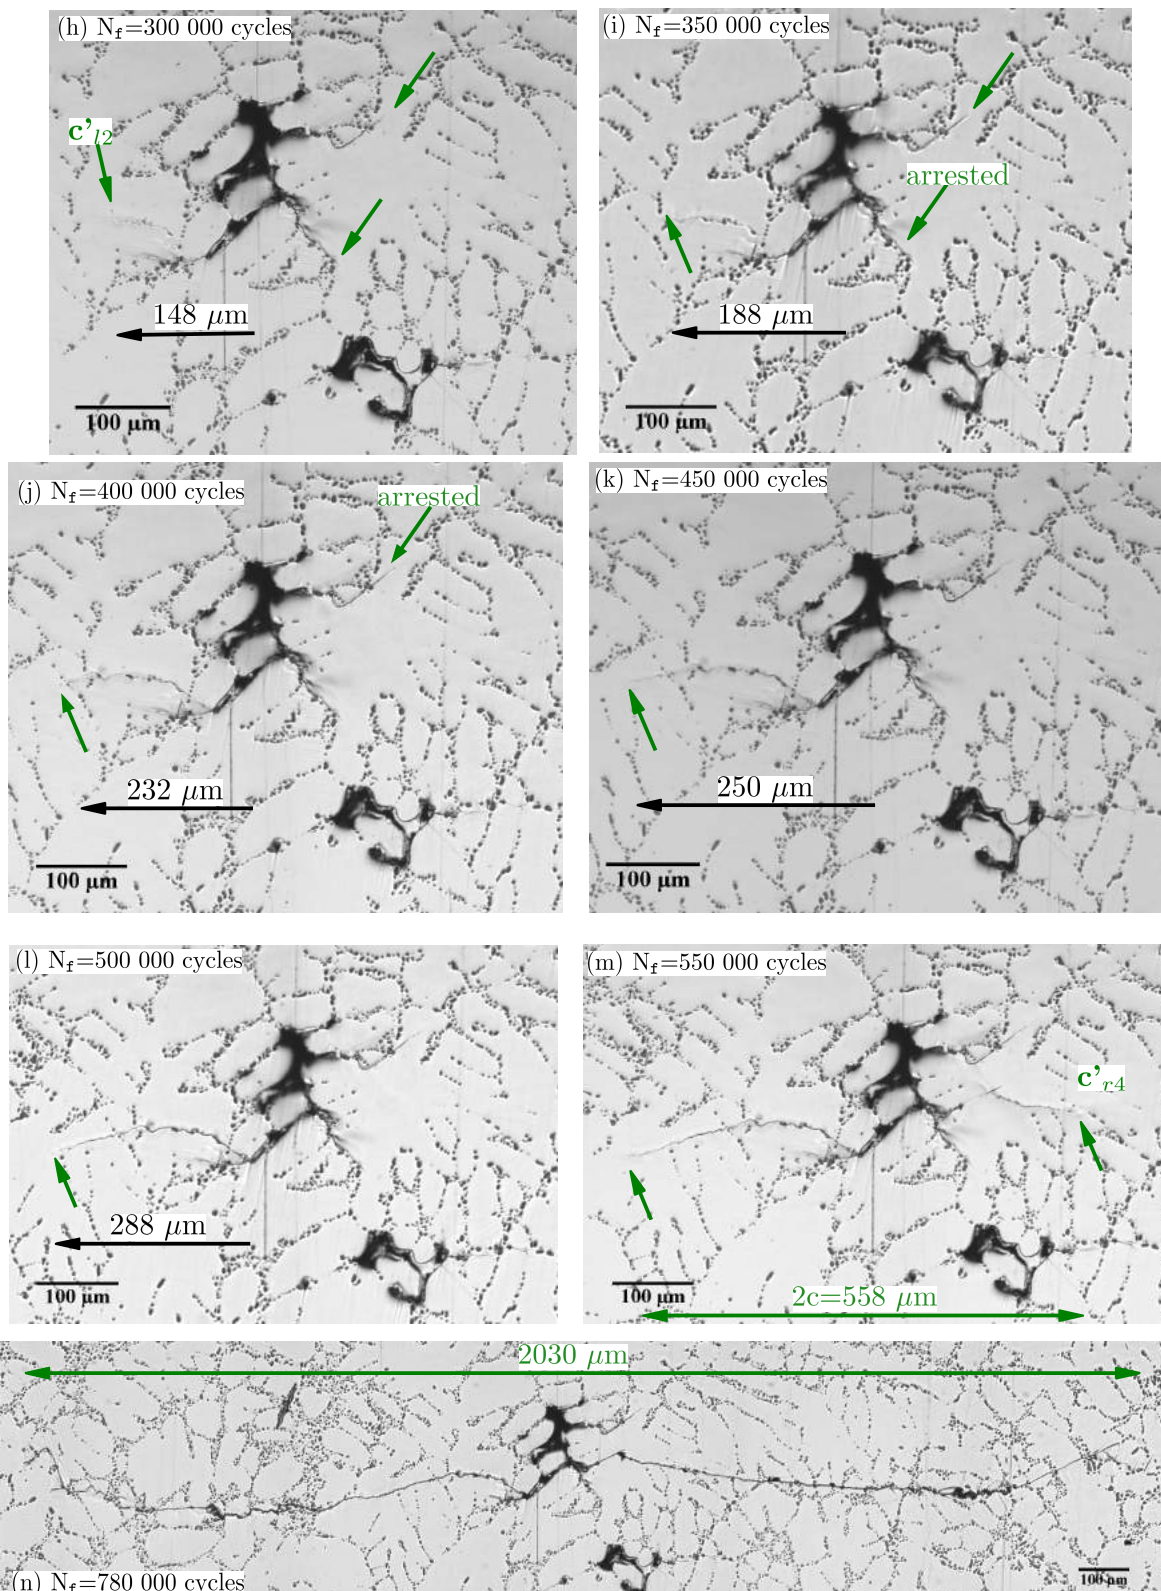
**Fig. 2.21:** (h)-(m) The same as the previous image but showing the crack progression between 300 000 and 550 000 cycles. This latter stage (m) presents the merging of the crack on the right side of the pore. (n) Optical image of the last stage (780 000 cycles).

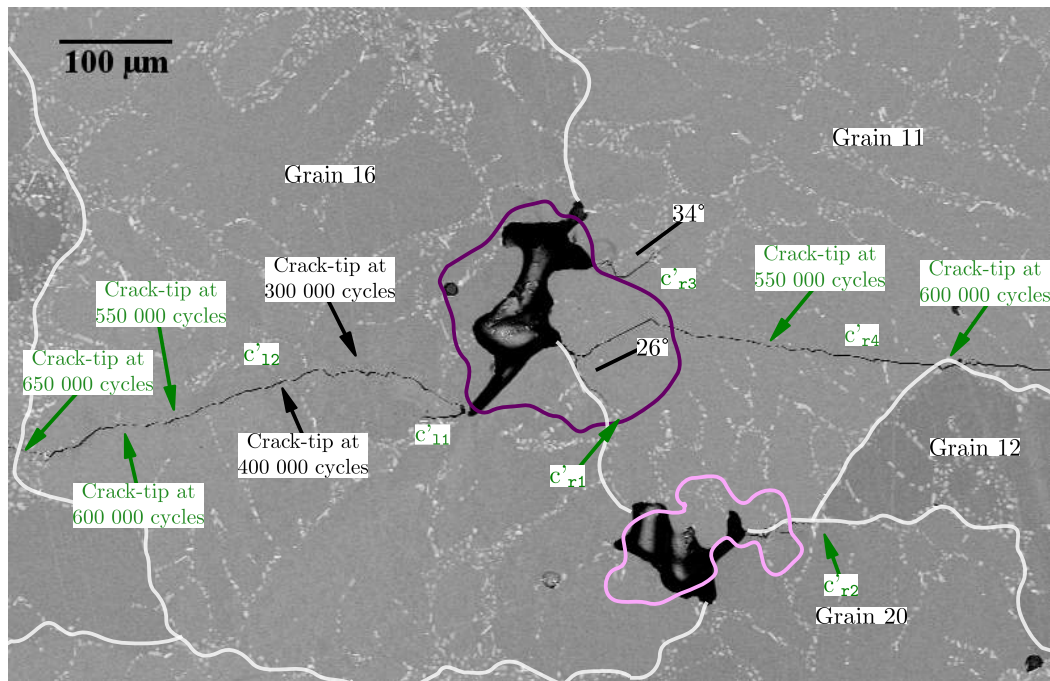
**Fig. 2.23:** EBS image of the nucleating pores where the grain boundaries are shown with white lines. The outlines in magenta and pink correspond to the approximate location of the underlying pores obtained using the tomographic images.

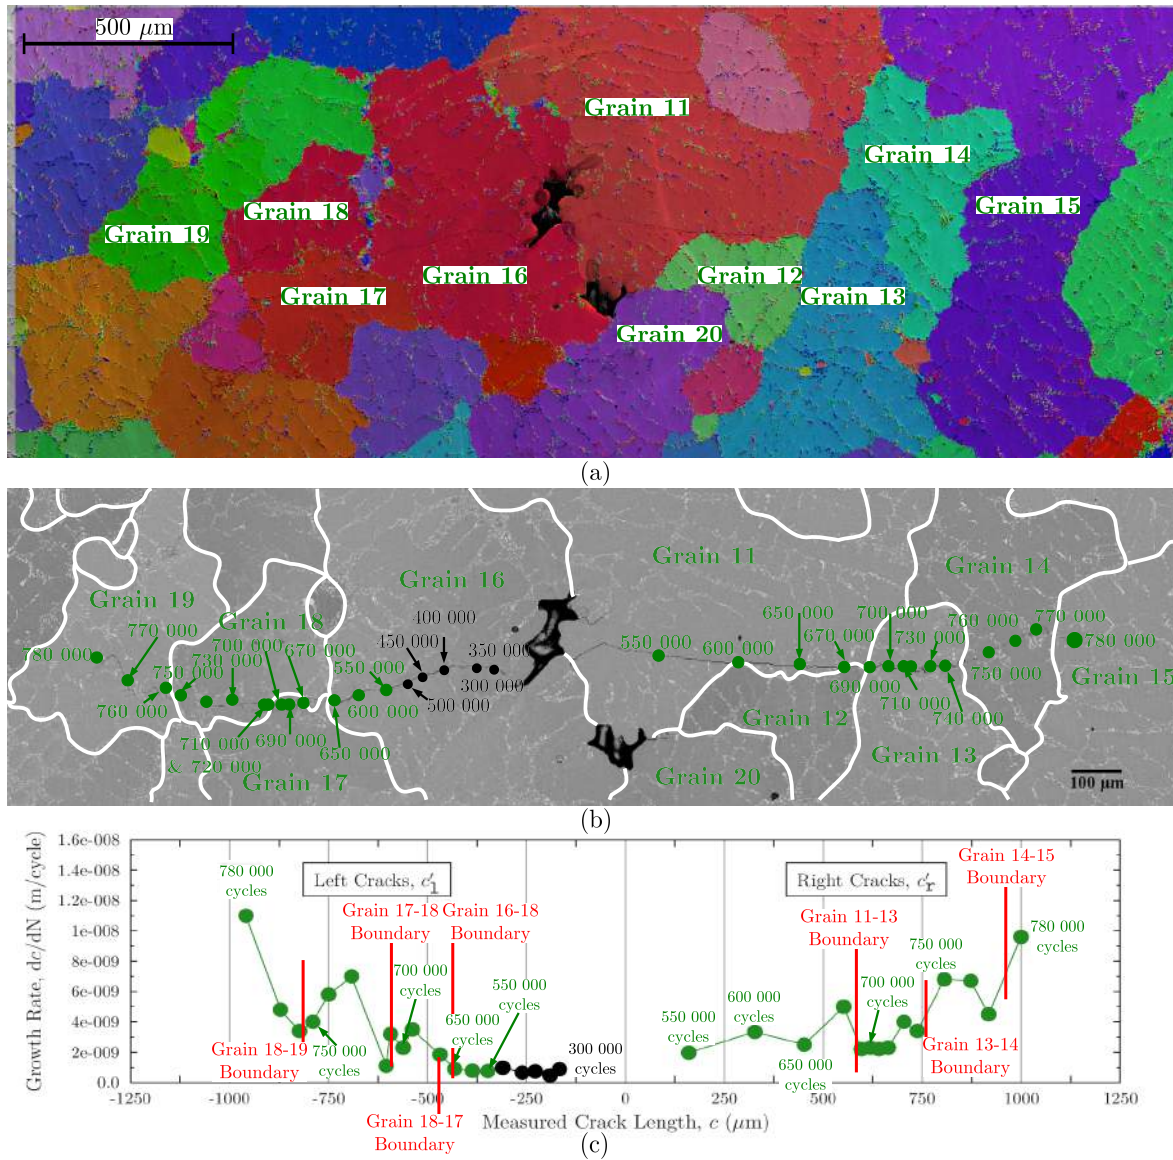
**Fig. 2.24:** (a) EBSD Euler map of the grain population around the pores and cracks. (b) BSE image of the crack path with green circles indicating the different stages of the propagation from 50 000 to 780 000 cycles. The white lines correspond to the approximate location of grain boundaries. (c) Plot of the crack growth rates ( $dc/dN$ ) against the measured crack lengths ( $c$ ).

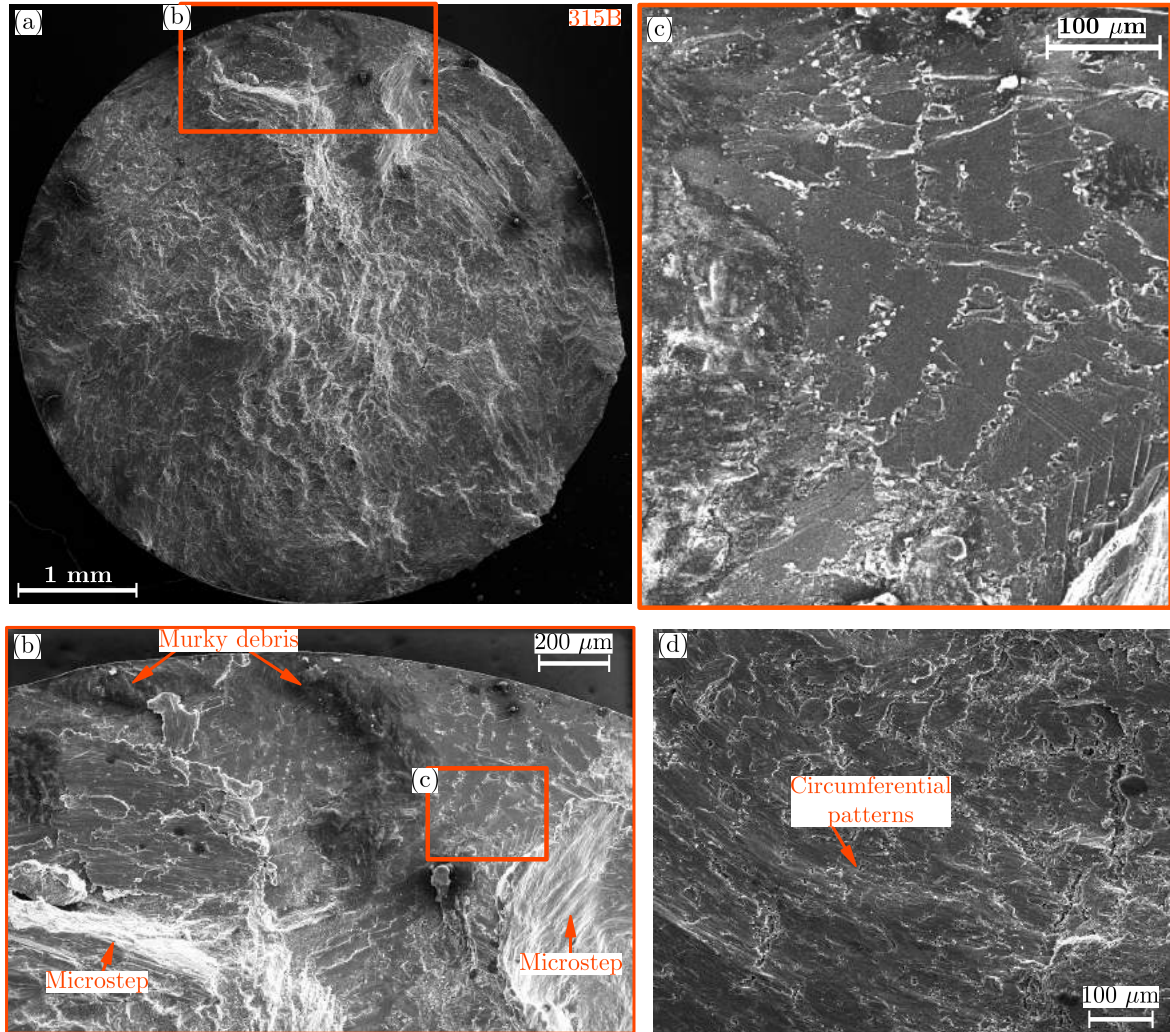
**Fig. 2.41:** (a) SEM observation at low magnification on the fracture surface of 315B specimen. The testing parameters are:  $\tau_{\max} = 110$  MPa,  $N_f = 110\,904$  cycles. (b) Higher magnification on one of the nucleation sites observed. Some murky debris and two microsteps can be observed. (c) Detail on the crystallographic facets formed at nucleation sites. (d) Higher magnification on a mode III fracture surface showing some circumferential patterns (also known as rubbing marks).

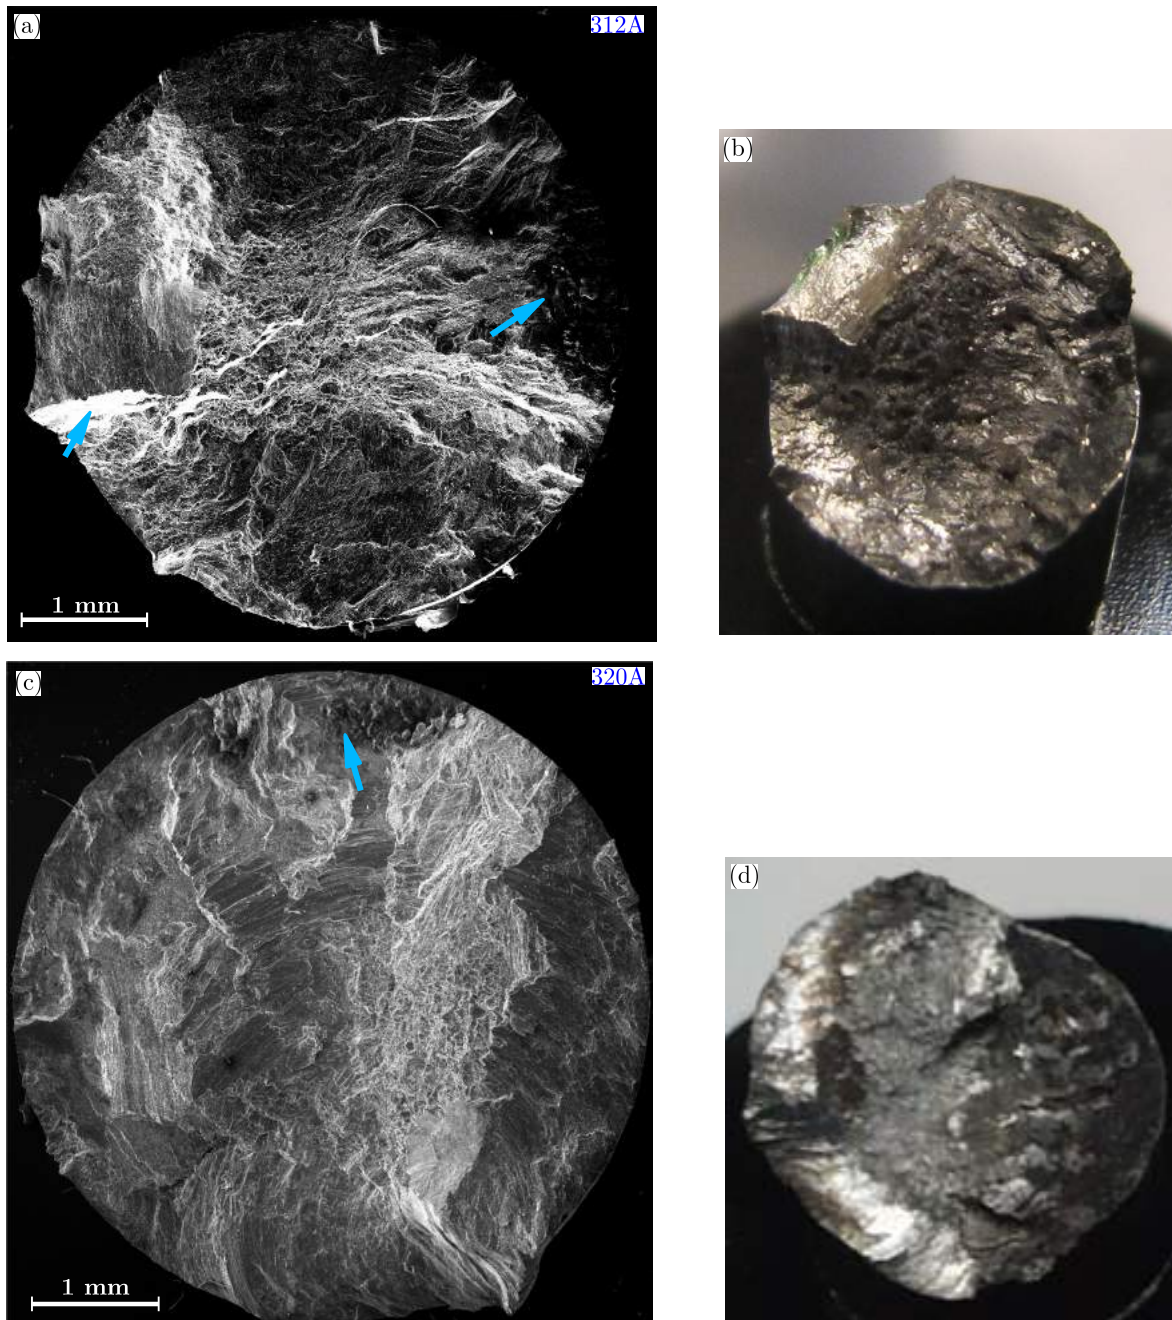
**Fig. 2.42:** (a) SEM observation at low magnification on the fracture surface of 312A specimen. The fatigue testing parameters are:  $N_f = 1\,419\,053$  cycles,  $\tau_{\max} = 95$  MPa. (b) 3D optical observation on the fracture surface of 312A specimen. (c) SEM observation at low magnification on the fracture surface of 320A specimen. The fatigue testing parameters are:  $N_f = 1\,419\,053$  cycles,  $\tau_{\max} = 95$  MPa. (d) 3D optical observation on the fracture surface of 320A specimen. The right blue arrow on image (a) and the one on image (c) indicate nucleation sites. Higher magnification of these sites is given in Fig. 2.43. Left blue arrow on image (a) indicates a region of mode I propagation (see Fig. 2.44).

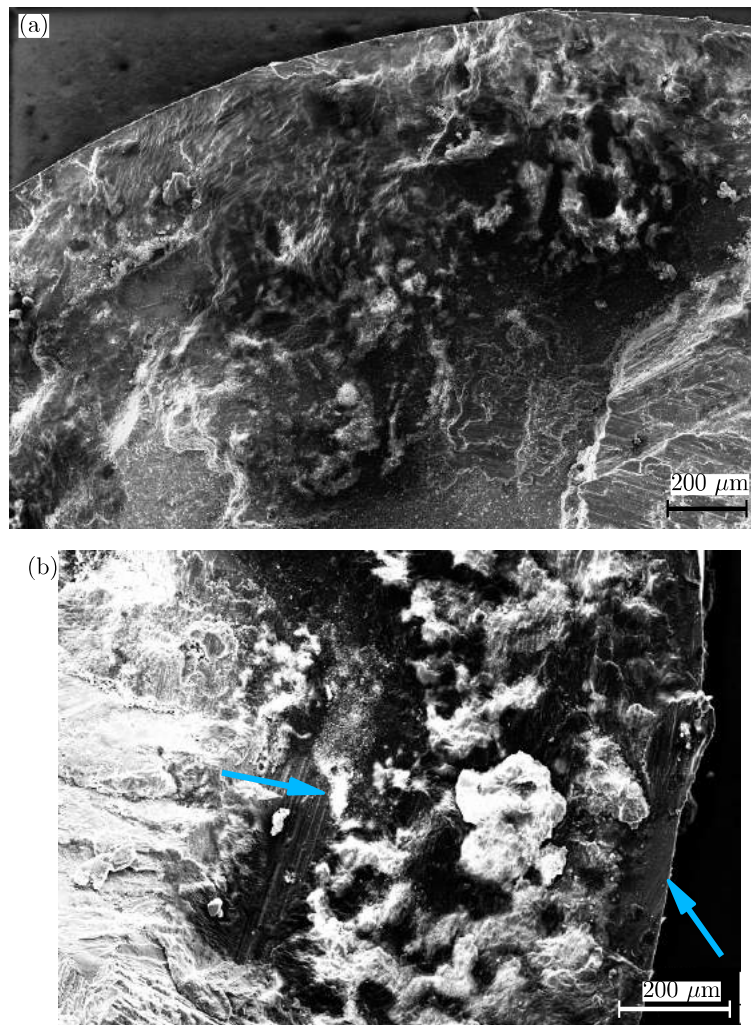
**Fig. 2.43:** (a) Higher magnification on 320A fracture surface where a thick murky layer fouls and mask the nucleation site. (b) The same as before but for 312A specimen. Here, some crystallographic facets (blue arrows) can be observed.

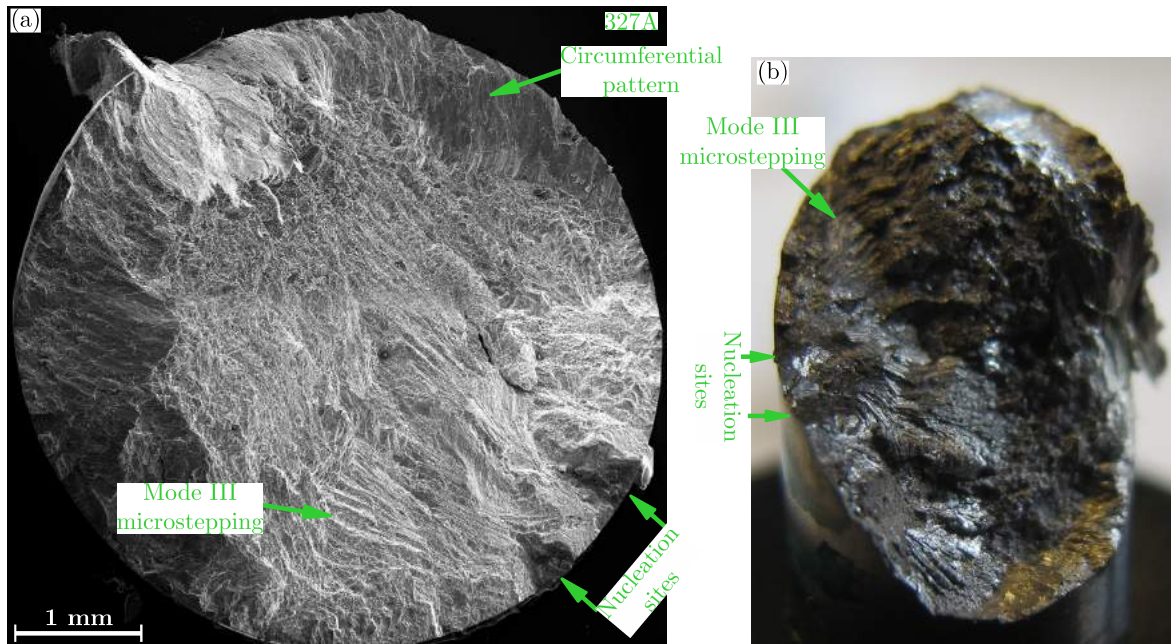
**Fig. 2.45:** (a) SEM observation at low magnification on the fracture surface of 327A specimen. The fatigue testing parameters are:  $N_f = 5\,200\,201$  cycles,  $\tau_{\max} = 80$  MPa. (b) 3D optical observation on the fracture surface of 327A specimen.

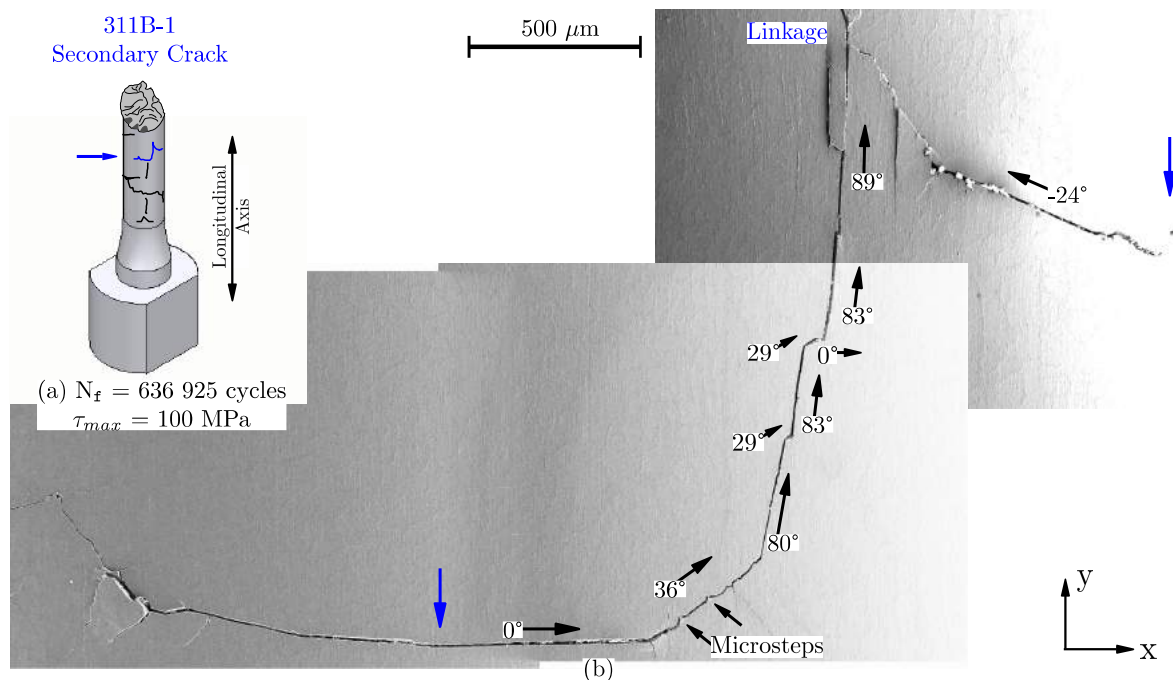
**Fig. 2.46:** (a) Schematic illustration of one half of the fractured gage showing the location of 311B-1 secondary crack. (b) SEM image of this crack where the two blue arrows indicate the presumed locations of the nucleation sites.

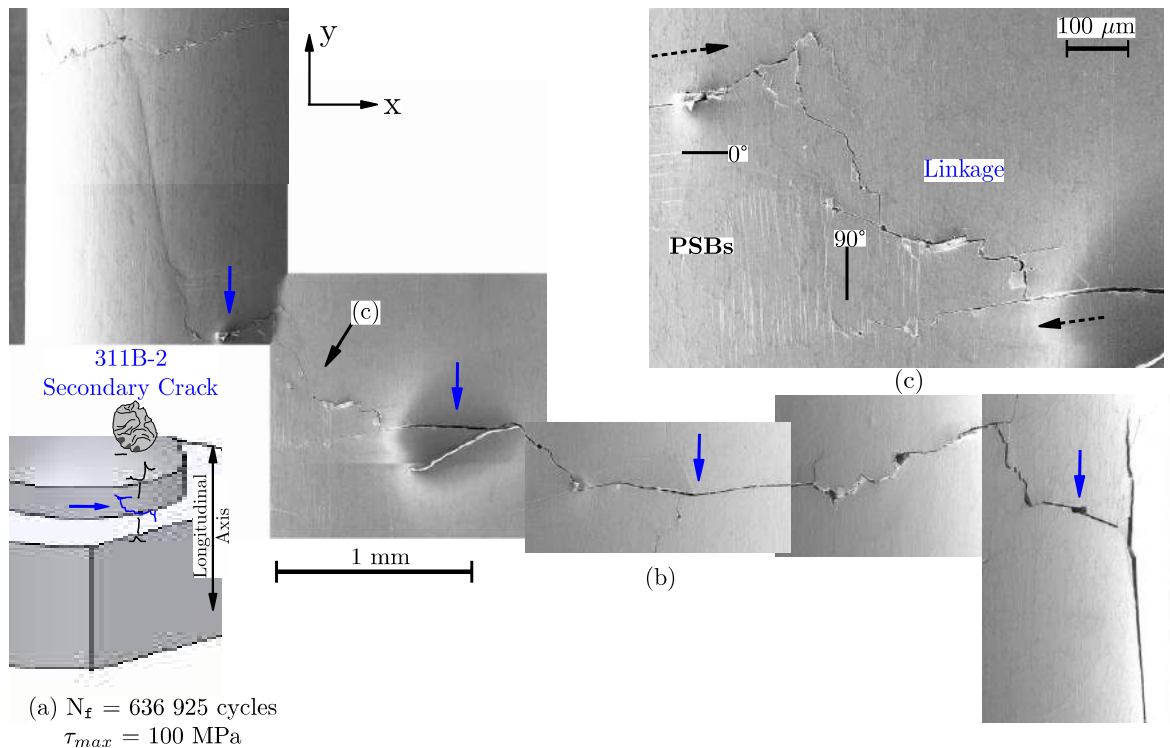
**Fig. 2.47:** (a) Schematic illustration of one half of the fractured gage showing the location of 311B-2 secondary crack. (b) SEM image of this extensive crack which is presumed to be the result of several linkages. (c) Higher magnification of a linking point where some PSBs at  $0^\circ$  and  $90^\circ$  can be observed.

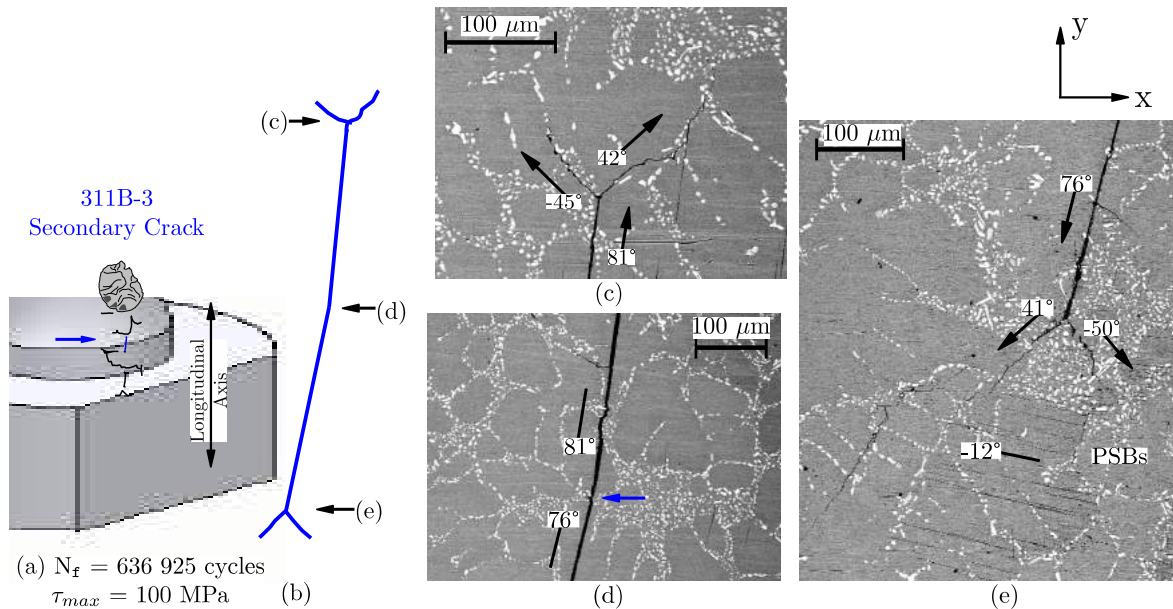
**Fig. 2.48:** (a) Schematic illustration of one half of the fractured gage showing the location of 311B-3 secondary crack. (b) Schematic drawing of this longitudinal crack where the arrows indicate the points of crack branching and deflection. (c) BSE image of the crack branching occurring at the top. (d) BSE image of the crack deflection at the middle. (e) BSE image of the crack branching at the bottom.

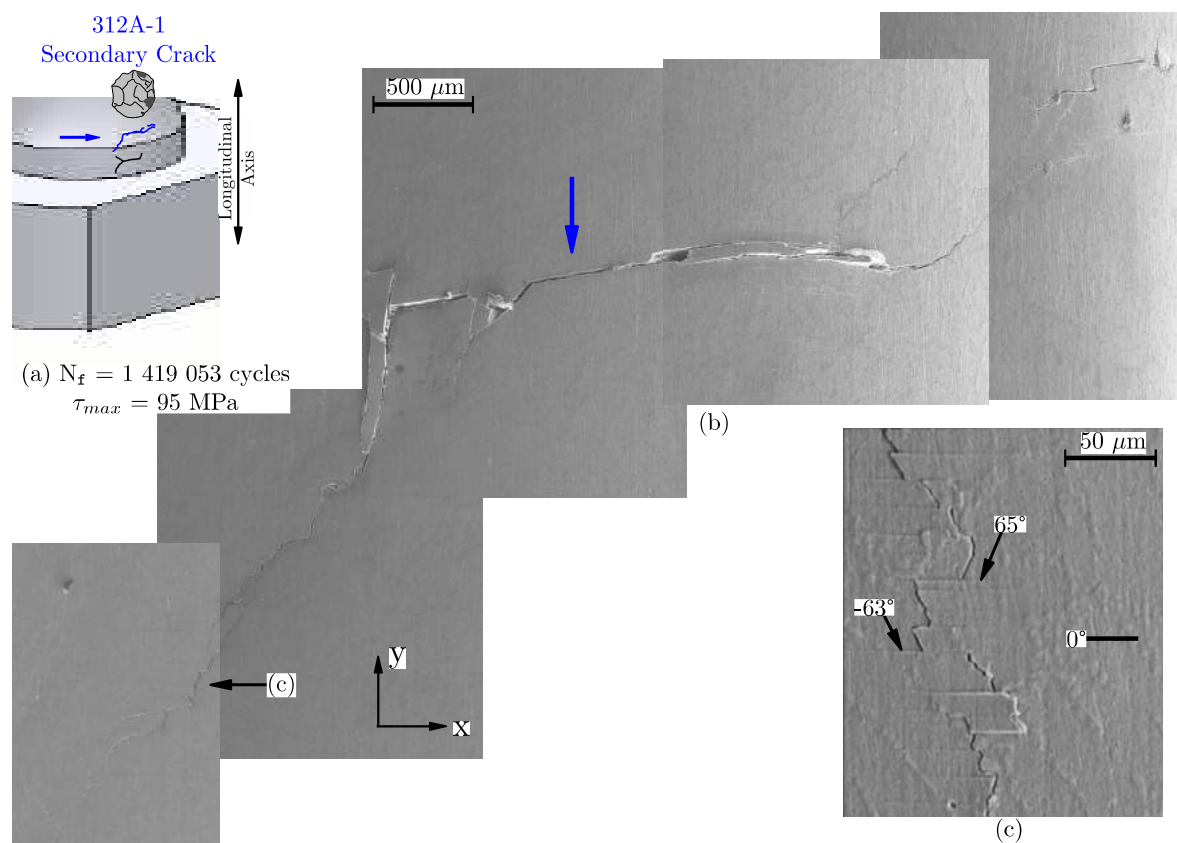
**Fig. 2.50:** (a) Schematic illustration of one half of the fractured gage showing the location of 312A-1 secondary crack. Two cracks were observed on this gage. (b) SEM image of the crack path. The blue arrow indicates the presumed location of the nucleation site. (c) Higher magnification of the bottom left part of the crack.
